## Lunar Reconnaissance Orbiter spots Surveyor 1

Thu Oct 1, 2009 at 10:20 UTC

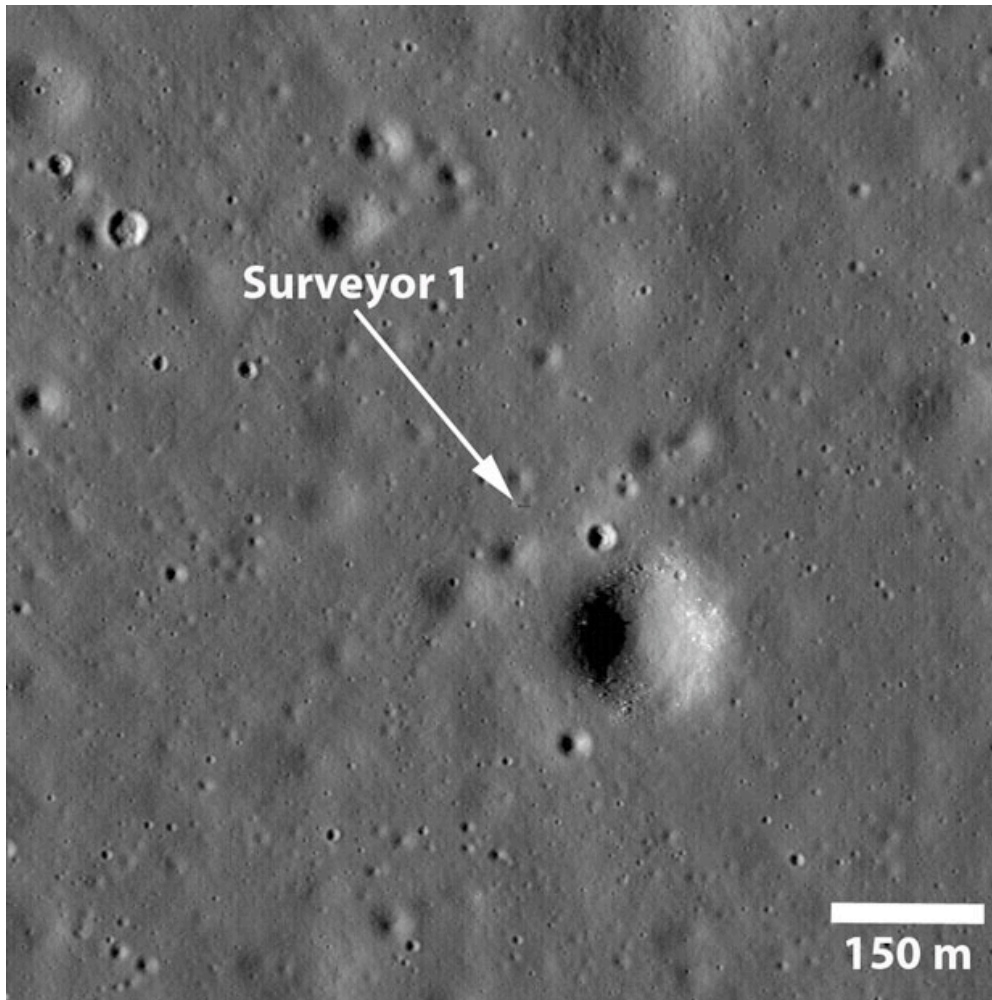
Surveyor 1 spacecraft sitting silently on Oceanus Procellarum, the first US spacecraft to land on another planet (June 2, 1966). The image was taken in the lunar afternoon such that the sun is low on the western horizon and the 3.3 meter tall spacecraft casts a long shadow (almost 15 m long) to the east. Credit: NASA/GSFC/Arizona State University

The scene shows the spacecraft (annotated with an arrow) just south of a subdued 40 m diameter crater and about 110 m northwest of a 190 m diameter crater lined with boulders. The landing site is in the northeast corner of the Flamsteed Ring, a 100 km diameter impact crater almost completely buried by mare lavas such that all that remains exposed is the upper part of the original crater rim.

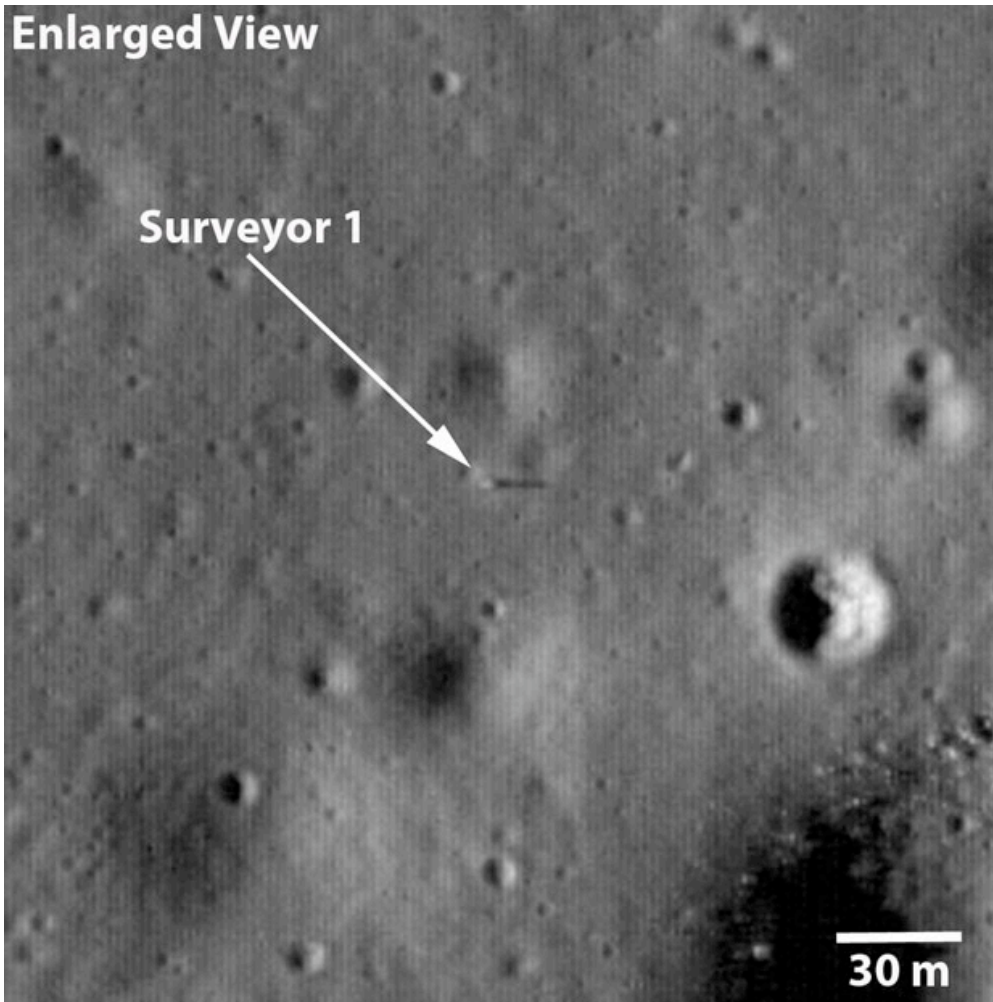
Enlarged view showing Surveyor 1 sitting in the Ocean of Storms, waiting for a return visit by human explorers. *Credit: NASA/GSFC/Arizona State University*

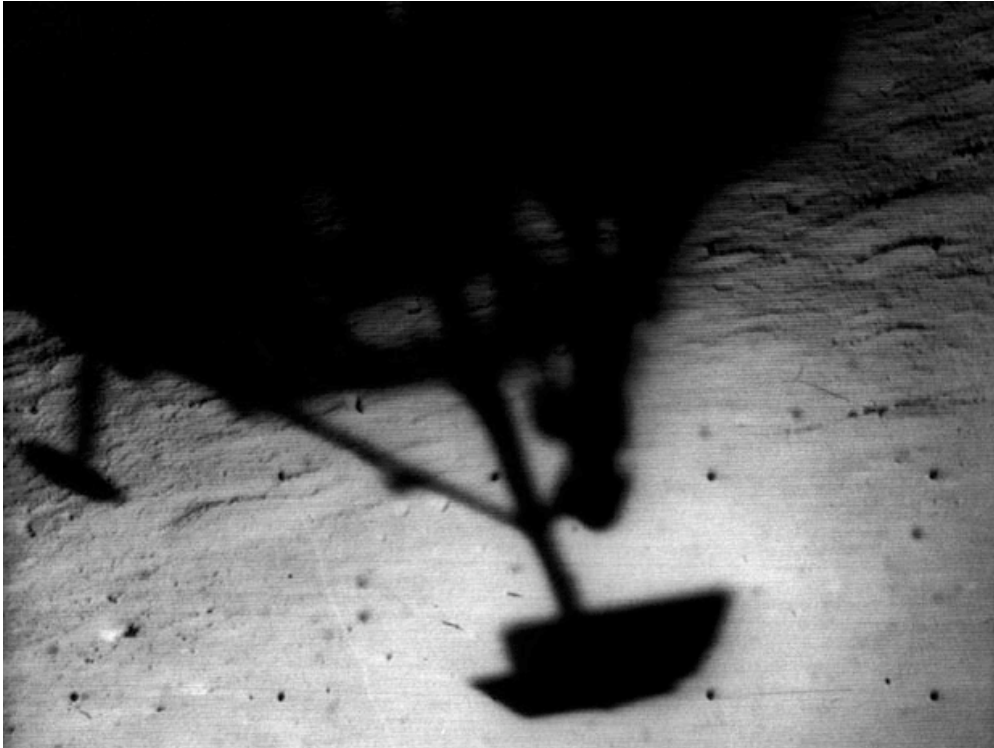
Image of Surveyor 1's shadow against the lunar surface, collected by the on-board imaging system. *Credit: NASA*

Surveyor 1 collected over 11,000 images, most during the first lunar day between landing and July 7, 1966. The spacecraft continued to operate until January 7, 1967. The Surveyor images demonstrated that the lunar surface was strong enough to support a landed vehicle or a human. The detailed images also indicated that the surface was composed of a granular material interpreted to be produced by the impact of various size meteors over billions of years.
